Annual Inspection

Walton Parish Council

Walton Play Area

Walton Village Green, Brampton, CA8 2DJ

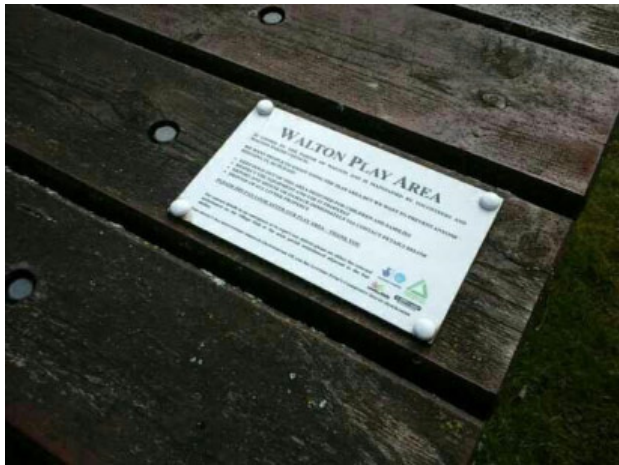
Item: Ancillary Items - Sign
Manufacturer: Owner/Operator
Surface Type: N/A
Equipment Compliance: N/A
Surface Area Compliance: N/A
Ref/Part Number:
Total Findings: 1

This item is satisfactory - no work required

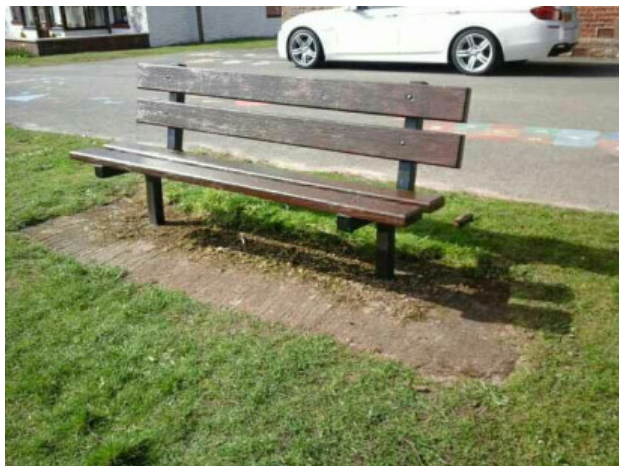
Item: Ancillary Items - Bench
Manufacturer: Owner/Operator
Surface Type: N/A
Equipment Compliance: N/A
Surface Area Compliance: N/A
Ref/Part Number:
Total Findings: 1

This item is satisfactory - no work required

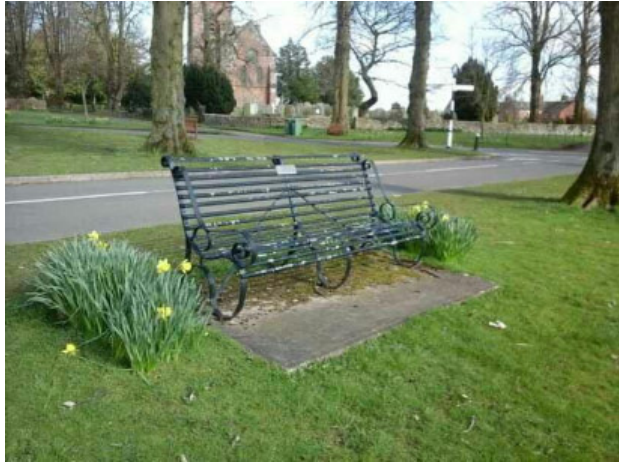
Item: Ancillary Items - Bench
Manufacturer: Owner/Operator
Surface Type: N/A
Equipment Compliance: N/A
Surface Area Compliance: N/A
Ref/Part Number:
Total Findings: 1

This item is satisfactory - no work required

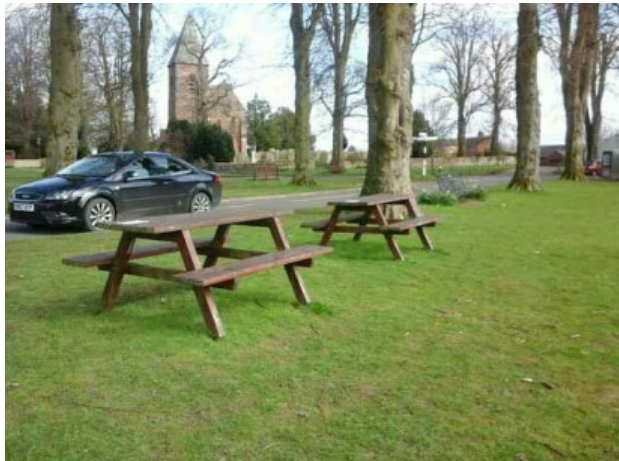
Item: Ancillary Items - Picnic Table
Manufacturer: Owner/Operator
Surface Type: N/A
Equipment Compliance: N/A
Surface Area Compliance: N/A
Ref/Part Number:
Total Findings: 1

There are projecting bolt thread(s) present - Remove excess thread length and deburr or provide cap

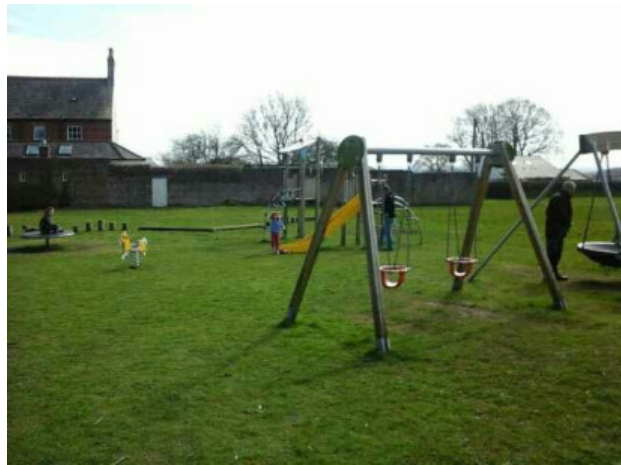
Item: Ancillary Items - Site General
Manufacturer: Owner/Operator
Surface Type: N/A
Equipment Compliance: N/A
Surface Area Compliance: N/A
Ref/Part Number:
Total Findings: 1

The grass mats are silted up and the soil is compacted; this may have an effect on the impact absorbing properties of the surface - Lift and relay mats or test impact absorbing properties to ensure the correct surface qualities are maintained for the equipment

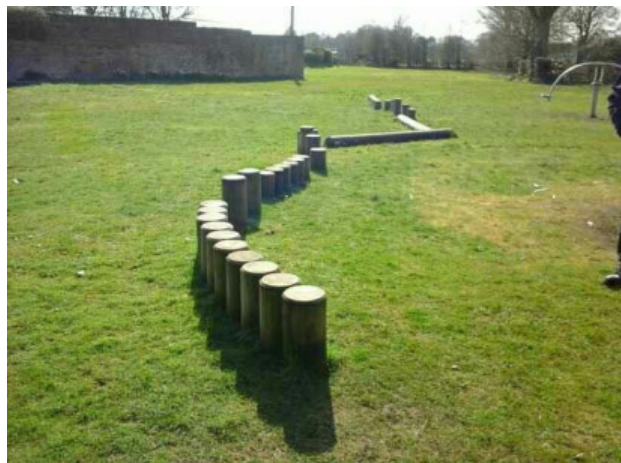
Item: Activity Equipment - Activity Trail
Manufacturer: Owner/Operator
Surface Type: Grass
Equipment Compliance: Yes
Surface Area Compliance: Yes
Ref/Part Number:
Total Findings: 2

There is some strimmer damage apparent on the posts, this can penetrate the preservative applied to the timber and accelerate the rotting process - Monitor for any deterioration (rot) and replace as required

There is some evidence of rot in the timber - Monitor for any further deterioration and replace as required

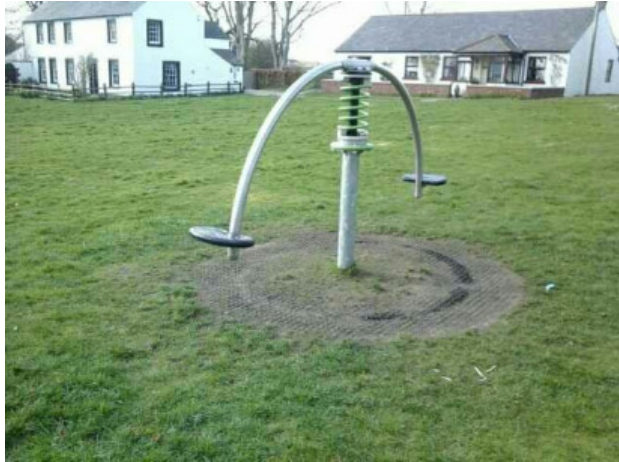
Item: Rotor Play - Gyro Spiral
Manufacturer: Proludic
Surface Type: Grass Matrix Tiles
Equipment Compliance: Yes
Surface Area Compliance: Yes
Ref/Part Number:
Total Findings: 1

Mats are broken - Replace

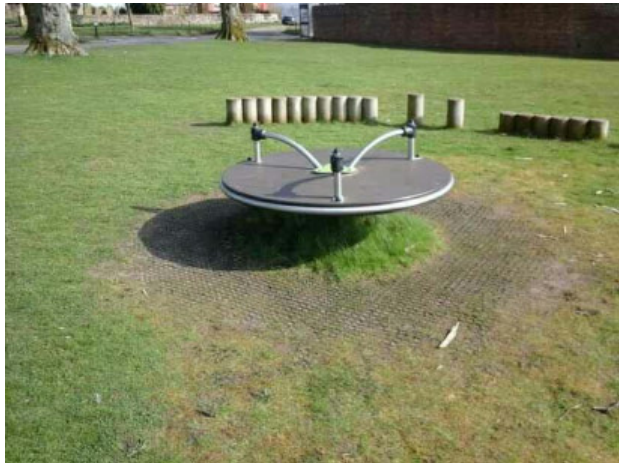
Item: Rotor Play - Roundabout
Manufacturer: Proludic
Surface Type: Grass Matrix Tiles
Equipment Compliance: No
Surface Area Compliance: Yes
Ref/Part Number:
Total Findings: 2

The height of the roundabout platform is less than 400mm and fails the requirements of BS EN 1176 Part 5 - Monitor use

The bearing is worn - Replace the bearing as required

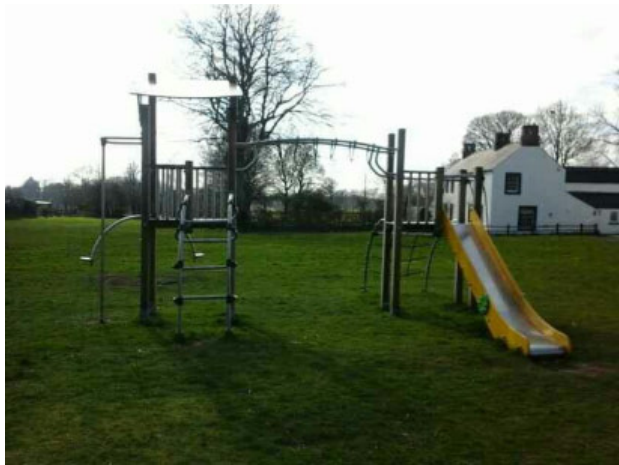
Item: Activity Equipment - Multi Play (Junior)
Manufacturer: Proludic
Surface Type: Grass Matrix Tiles
Equipment Compliance: No
Surface Area Compliance: Yes
Ref/Part Number:
Total Findings: 3

There is/are bolt cap covers missing or damaged on the item - Replace missing or damaged bolt cap covers

A number of fixing(s) have worked loose - Secure all loose fixings

Parts of the timber are rough or splintered - Remove all rough or sharp edges

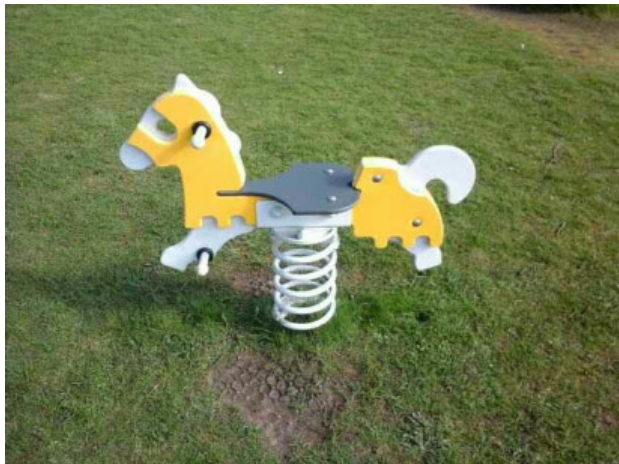
Item: Rocking Equipment - Spring Horse
Manufacturer: Proludic
Surface Type: Grass Matrix Tiles
Equipment Compliance: No
Surface Area Compliance: Yes
Ref/Part Number:
Total Findings: 2

The end of handgrips and/or footrests have a cross section of less than 15cm² and fail to meet the requirements of BS EN 1176:2008 Part 6 - This is a relatively low risk failure and no remedial action is recommended

A number of fixing(s) have worked loose - Secure all loose fixings

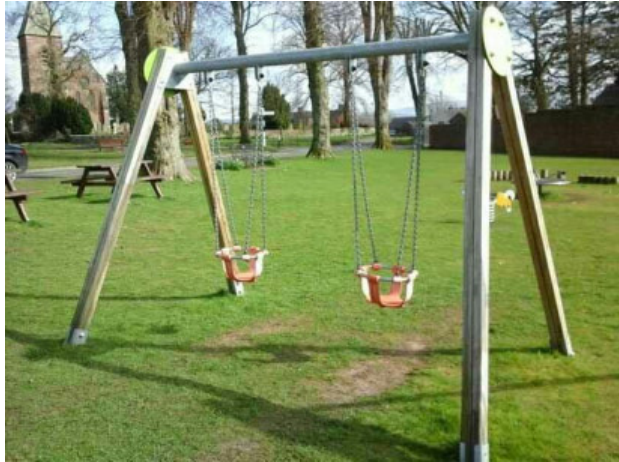
Item: Swings - 1 Bay 2 Seat (Cradle)
Manufacturer: Proludic
Surface Type: Grass Matrix Tiles
Equipment Compliance: Yes
Surface Area Compliance: Yes
Ref/Part Number:
Total Findings: 1

There are caps missing from the underside of the seats - Replace missing caps under the seats

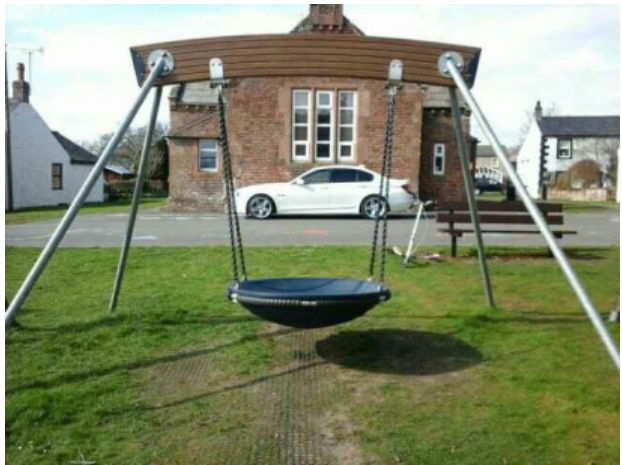
Item: Swings - Basket Swing - Type 1
Manufacturer: Proludic
Surface Type: Grass Matrix Tiles
Equipment Compliance: No
Surface Area Compliance: Yes
Ref/Part Number:
Total Findings: 6

The bushes are showing signs of wear - Monitor for any further deterioration and replace as required

There is/are bolt cap covers missing or damaged on the item - Replace missing or damaged bolt cap covers

There is surface corrosion present on the item - Consider treating and repainting the item

Swings of this design are strongly recommended to have a secondary safety mechanism fitted to prevent collapse of the seat - Consider providing a secondary safety mechanism

The seat clearance from finished surface level to the underside of the seat is too low when measured to the underside of the dish at its lowest position.
 - Install seats to a minimum height of 400mm for Tyre/Platform/Basket Seats

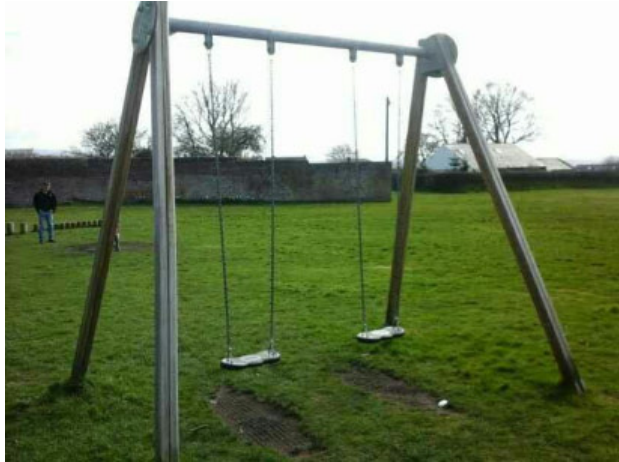
Item: Swings - 1 Bay 2 Seat (Flat)
Manufacturer: Proludic
Surface Type: Grass Matrix Tiles
Equipment Compliance: Yes
Surface Area Compliance: Yes
Ref/Part Number:
Total Findings: 1

There is some chain wear - Monitor for any further deterioration and replace when 40% worn

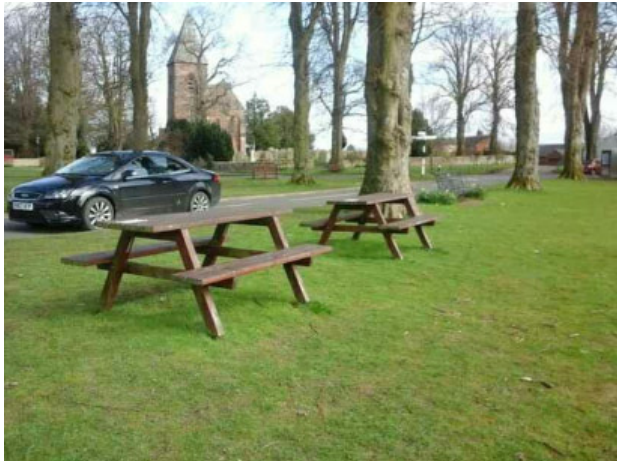
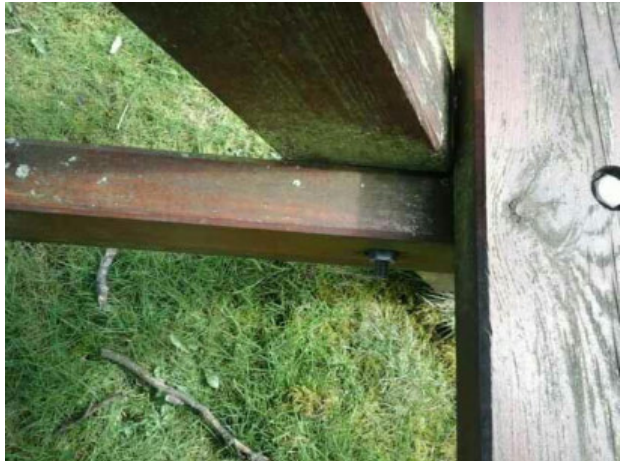
Item:	Ancillary Items - Picnic Table	Risk Level:	L - Low Risk
Manufacturer:	Owner/Operator	Surface:	N/A

Finding:	There are projecting bolt thread(s) present	Action:	Remove excess thread length and deburr or provide cap
-----------------	---	----------------	---

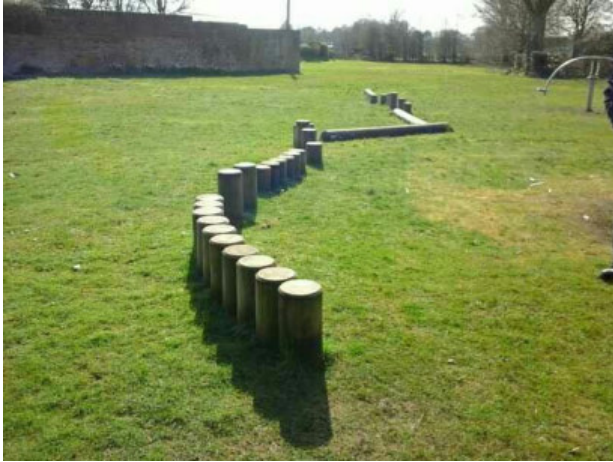
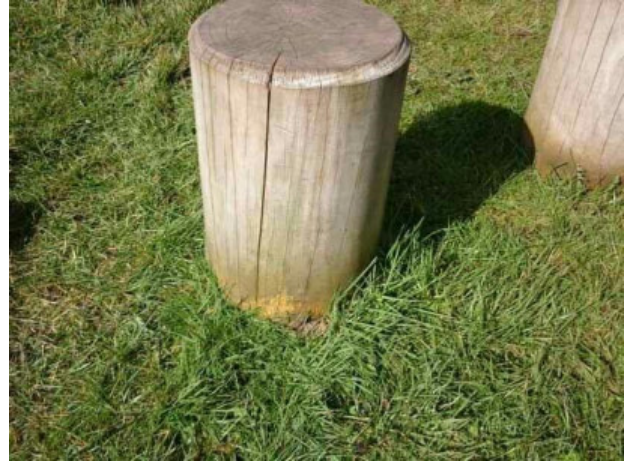
Item: Activity Equipment - Activity Trail
Manufacturer: Owner/Operator

Finding: There is some strimmer damage apparent on the posts, this can penetrate the preservative applied to the timber and accelerate the rotting process

Action: Monitor for any deterioration (rot) and replace as required

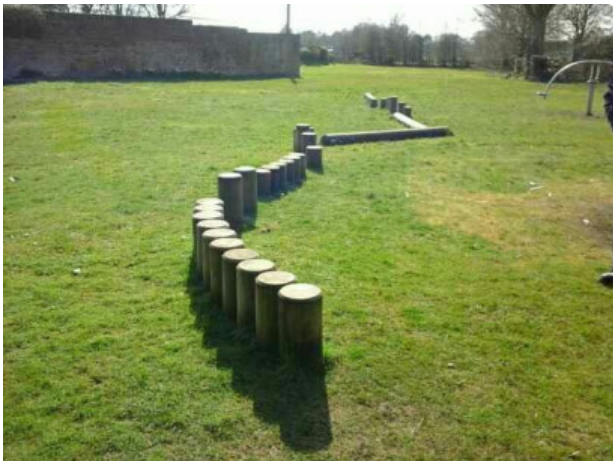
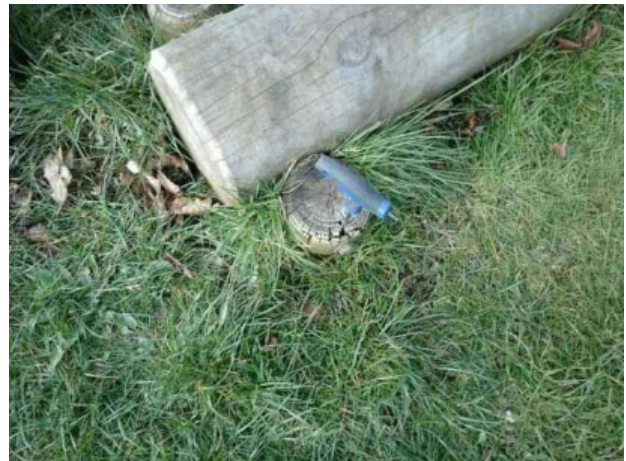
Item: Activity Equipment - Activity Trail
Manufacturer: Owner/Operator

Finding: There is some evidence of rot in the timber

Action: Monitor for any further deterioration and replace as required

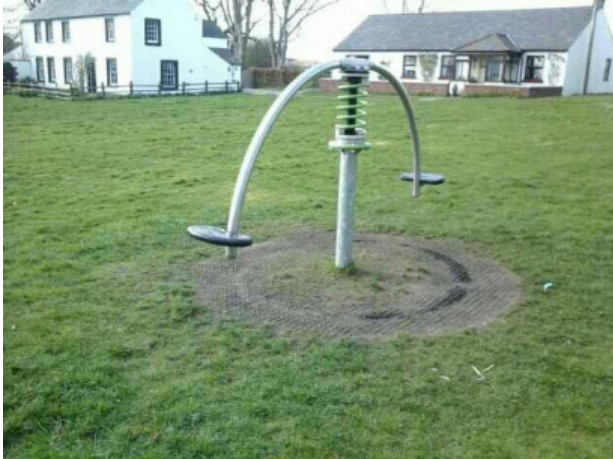
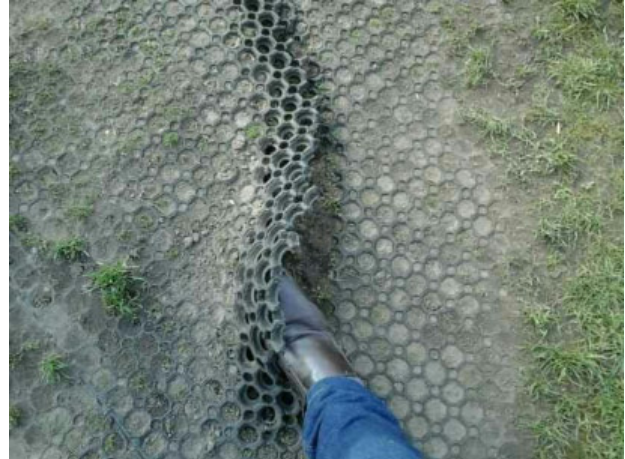
Item: Rotor Play - Gyro Spiral
Manufacturer: Proludic

Finding: Mats are broken

Action: Replace

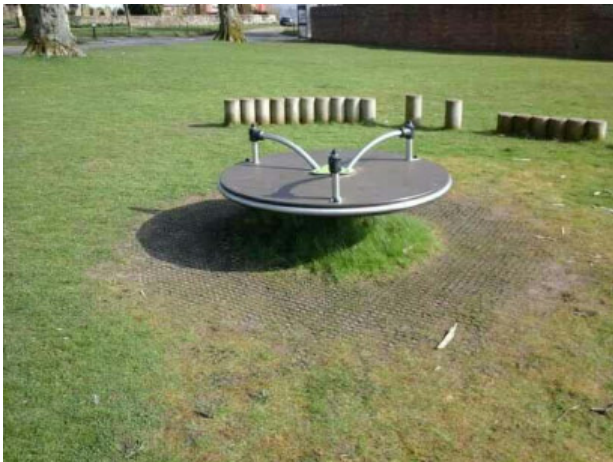
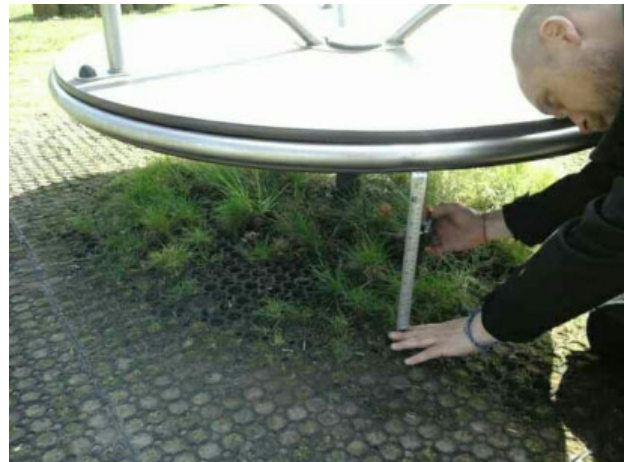
Item: Rotor Play - Roundabout
Manufacturer: Proludic

Finding: The height of the roundabout platform is less than 400mm and fails the requirements of BS EN 1176 Part 5

Action: Monitor use

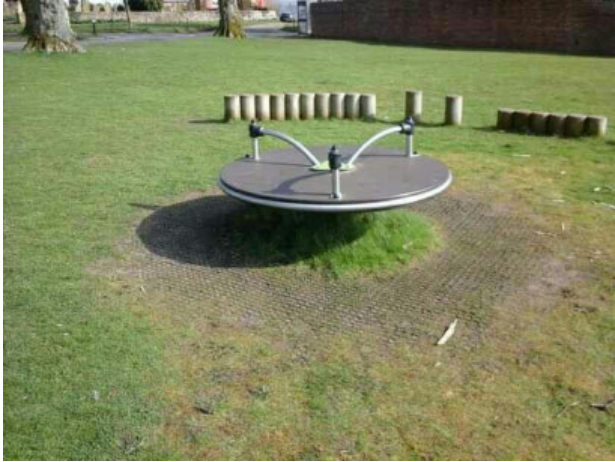
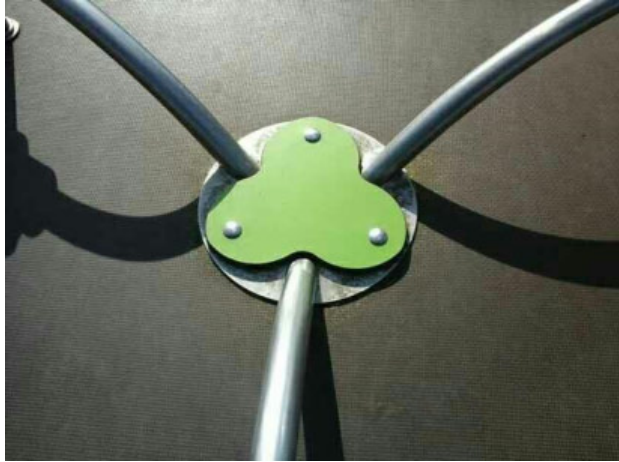
Item: Rotor Play - Roundabout
Manufacturer: Proludic

Finding: The bearing is worn

Action: Replace the bearing as required

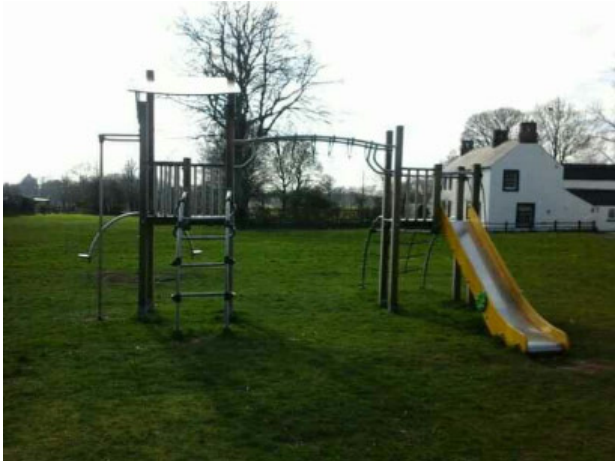
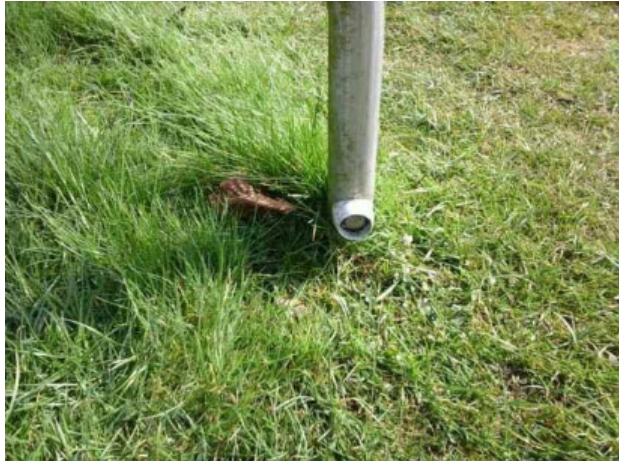
Item: Activity Equipment - Multi Play (Junior)
Manufacturer: Proludic

Finding: There is/are bolt cap covers missing or damaged on the item

Action: Replace missing or damaged bolt cap covers

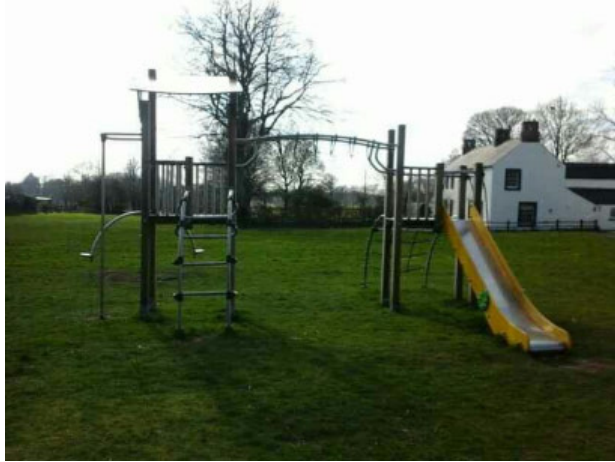
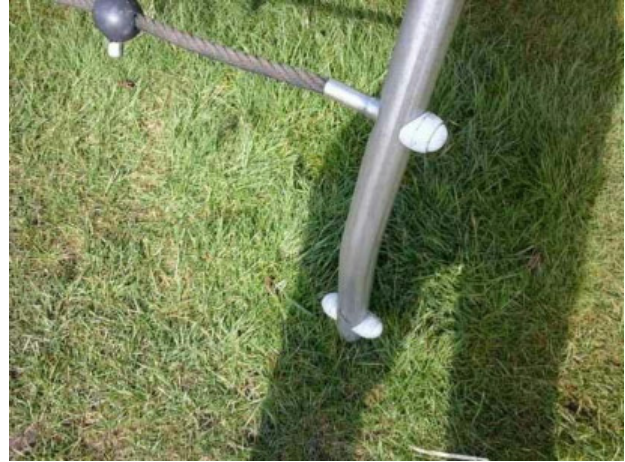
Item: Activity Equipment - Multi Play (Junior)
Manufacturer: Proludic

Finding: A number of fixing(s) have worked loose

Action: Secure all loose fixings

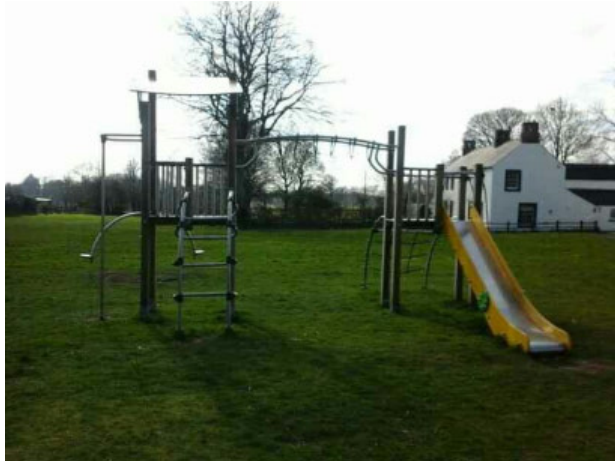
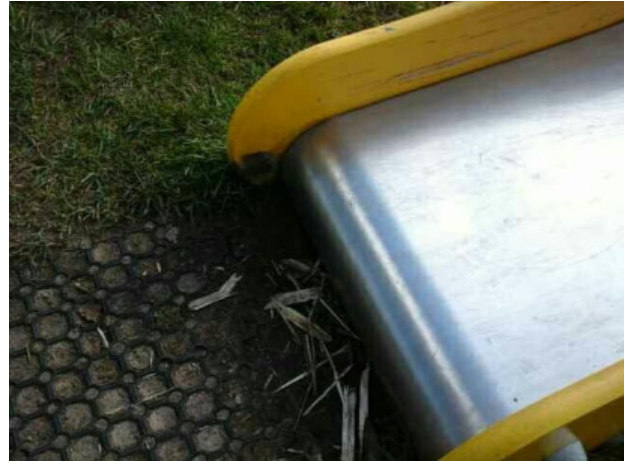
Item: Activity Equipment - Multi Play (Junior)
Manufacturer: Proludic

Finding: Parts of the timber are rough or splintered

Action: Remove all rough or sharp edges

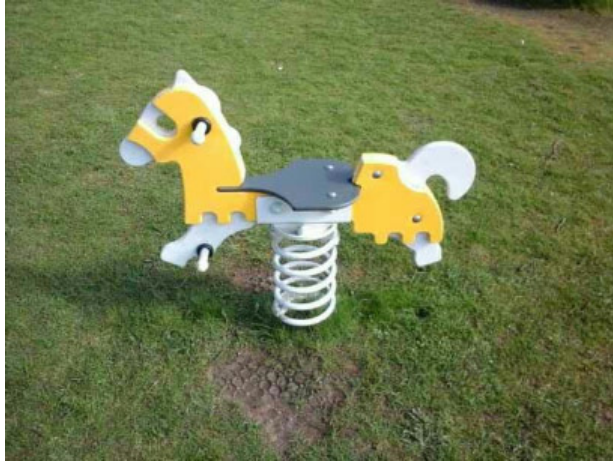
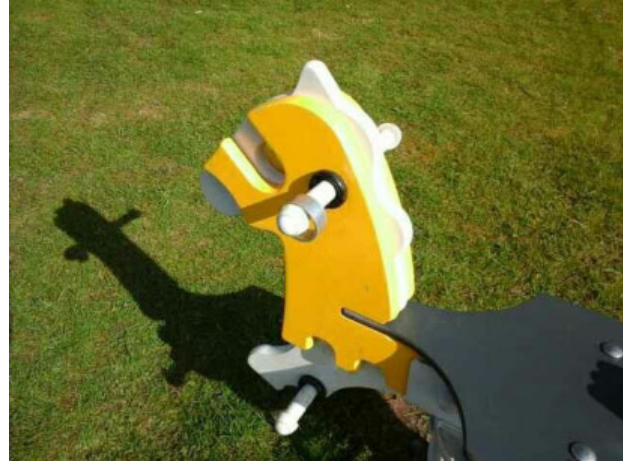
Item: Rocking Equipment - Spring Horse
Manufacturer: Proludic

Finding: The end of handgrips and/or footrests have a cross section of less than 15cm² and fail to meet the requirements of BS EN 1176:2008 Part 6

Action: This is a relatively low risk failure and no remedial action is recommended

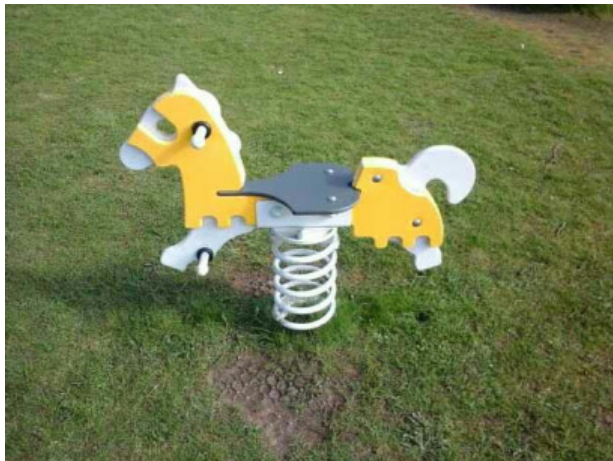
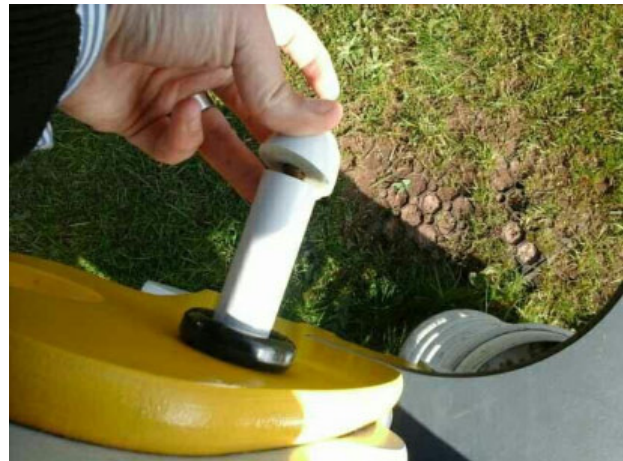
Item: Rocking Equipment - Spring Horse
Manufacturer: Proludic

Finding: A number of fixing(s) have worked loose

Action: Secure all loose fixings

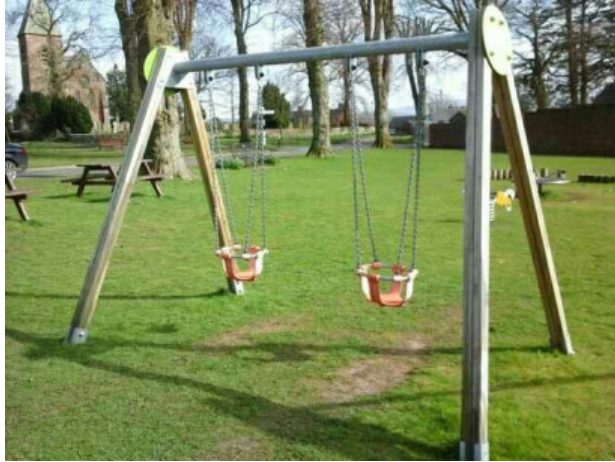
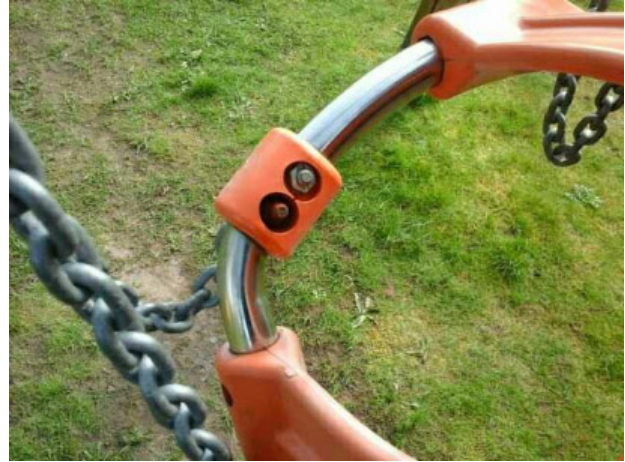
Item: Swings - 1 Bay 2 Seat (Cradle)
Manufacturer: Proludic

Finding: There are caps missing from the underside of the seats
Action: Replace missing caps under the seats

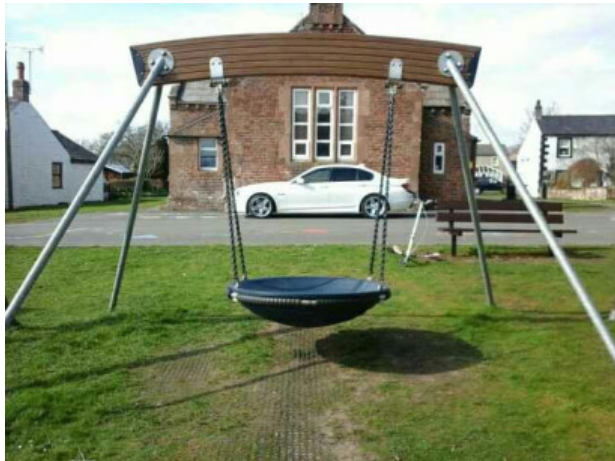
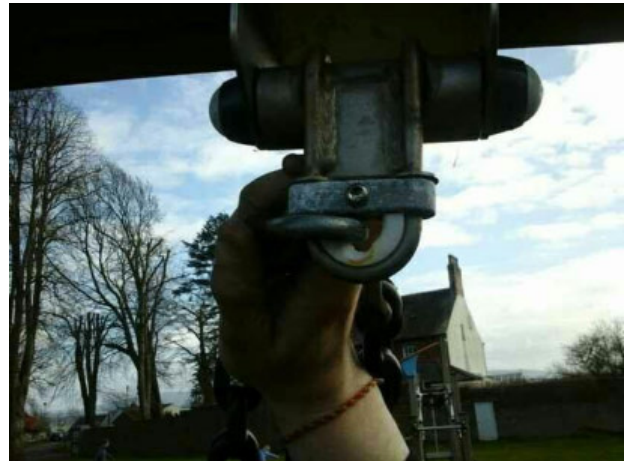
Item: Swings - Basket Swing - Type 1
Manufacturer: Proludic

Finding: The bushes are showing signs of wear
Action: Monitor for any further deterioration and replace as required

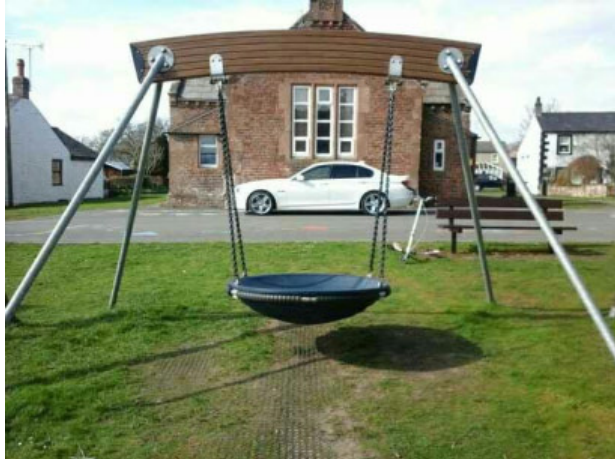
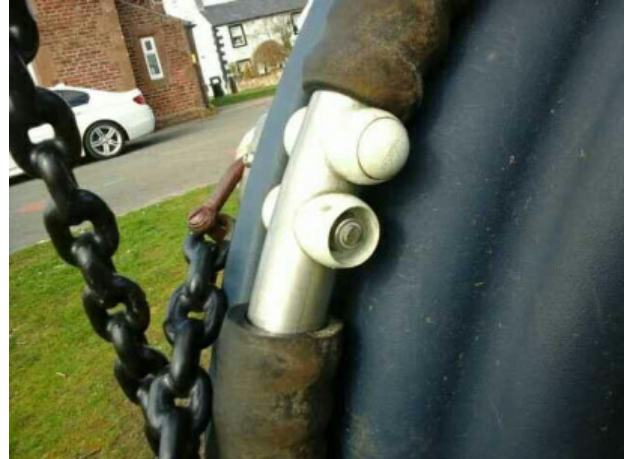
Item: Swings - Basket Swing - Type 1
Manufacturer: Proludic

Finding: There is/are bolt cap covers missing or damaged on the item

Action: Replace missing or damaged bolt cap covers

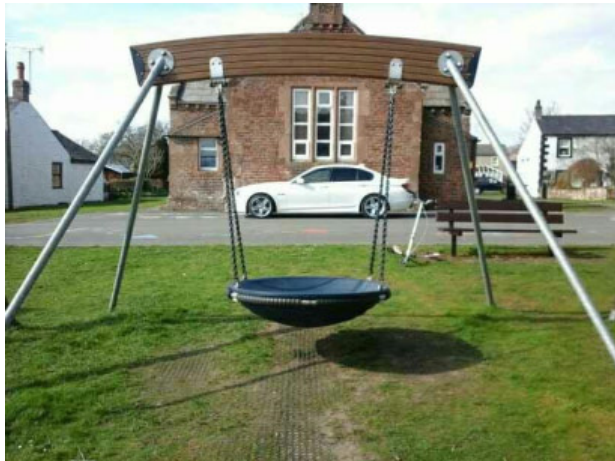
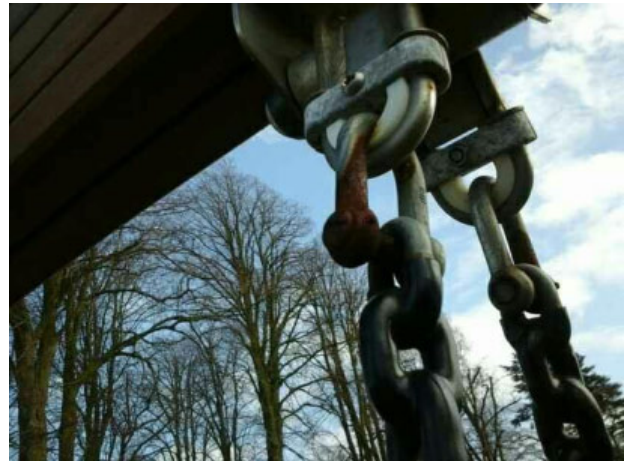
Item: Swings - Basket Swing - Type 1
Manufacturer: Proludic

Finding: There is surface corrosion present on the item

Action: Consider treating and repainting the item

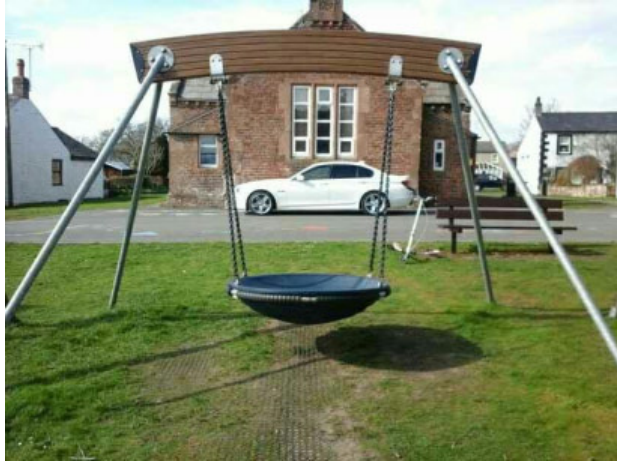
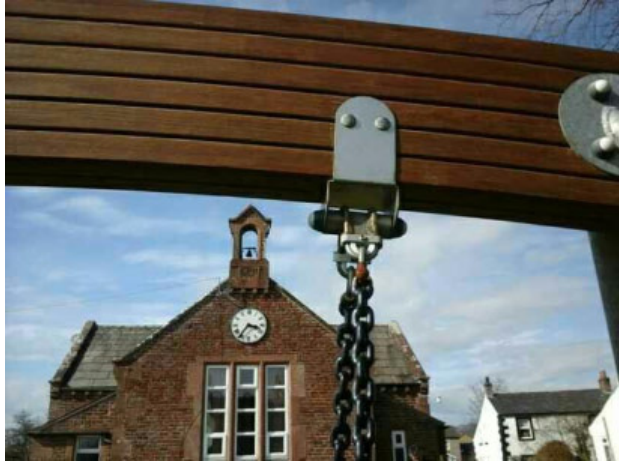
Item: Swings - Basket Swing - Type 1
Manufacturer: Proludic

Finding: Swings of this design are strongly recommended to have a secondary safety mechanism fitted to prevent collapse of the seat

Action: Consider providing a secondary safety mechanism

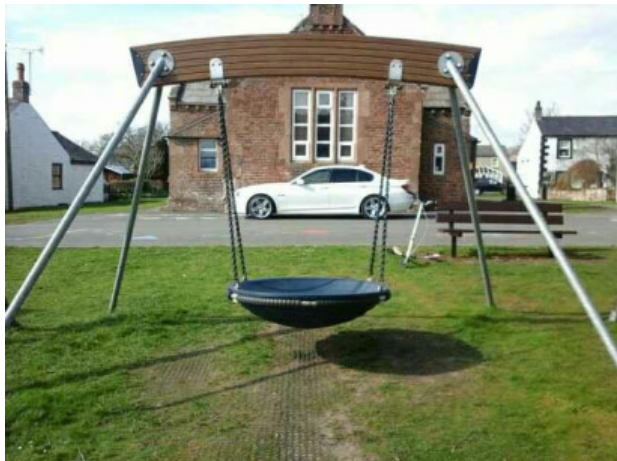
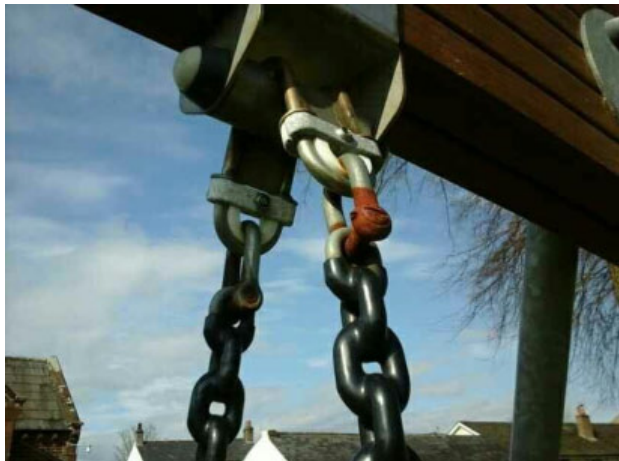
Item: Swings - Basket Swing - Type 1
Manufacturer: Proludic

Finding: There is surface corrosion present on the item

Action: Consider treating and repainting the item

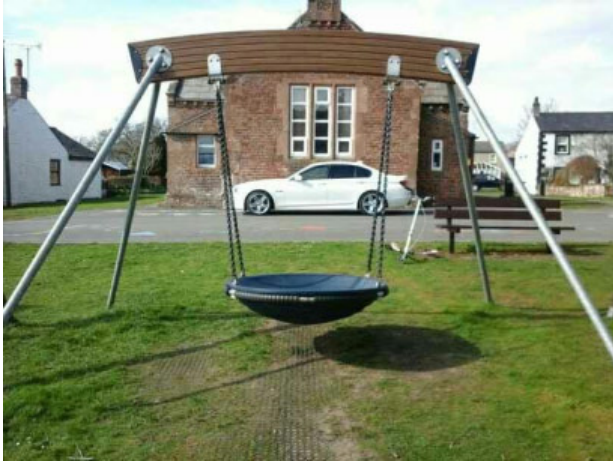
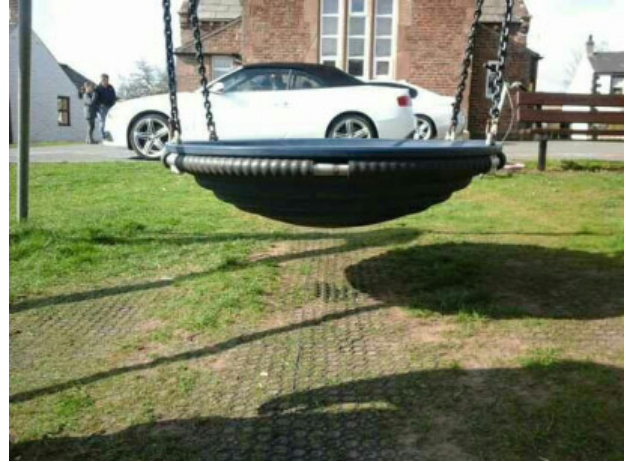
Item: Swings - Basket Swing - Type 1
Manufacturer: Proludic

Finding: The seat clearance from finished surface level to the underside of the seat is too low when measured to the underside of the dish at its lowest position.

Action: Install seats to a minimum height of 400mm for Tyre/Platform/Basket Seats

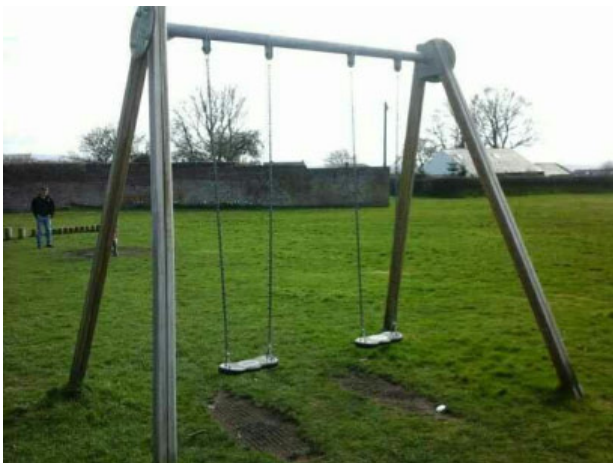
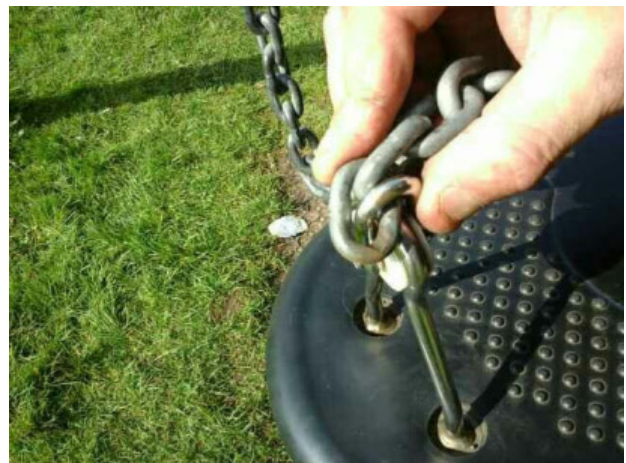
Item: Swings - 1 Bay 2 Seat (Flat)
Manufacturer: Proludic

Finding: There is some chain wear

Action: Monitor for any further deterioration and replace when 40% worn
